Continuous-Fiber Ceramic Composites (CFCCs) For Industrial Gas Turbines

Karren L. More and Peter F. Tortorelli

Oak Ridge National Laboratory, Oak Ridge, TN

*Presented at the
DER Materials Peer Review Meeting*

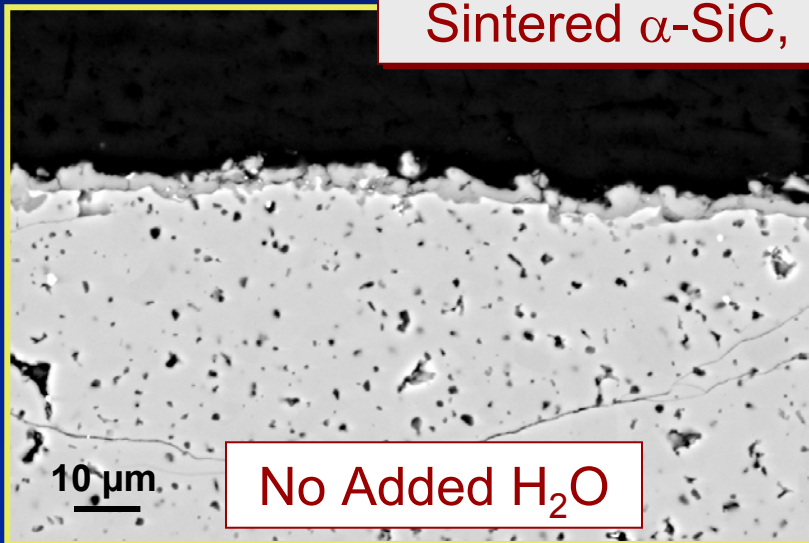
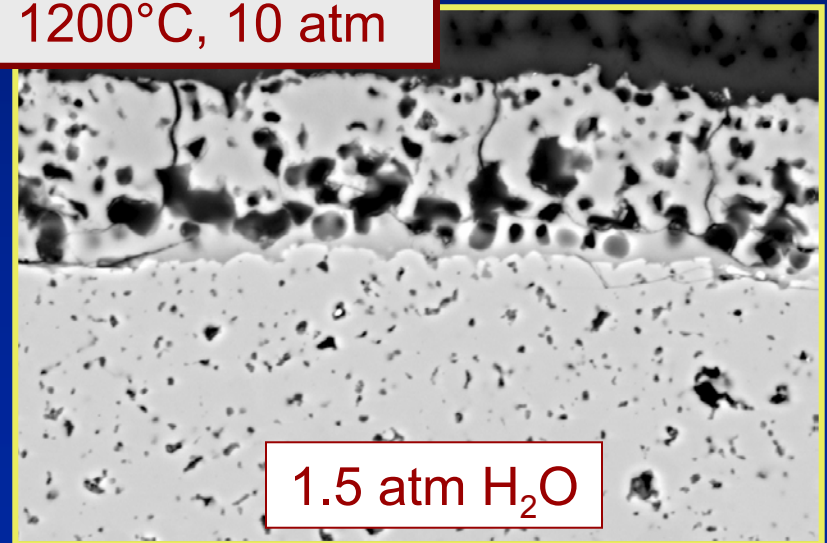
At Higher Pressures Of Water Vapor (>1 atm), Oxidative Degradation Is Significant

Sintered α -SiC, 100 h, 1200°C, 10 atm

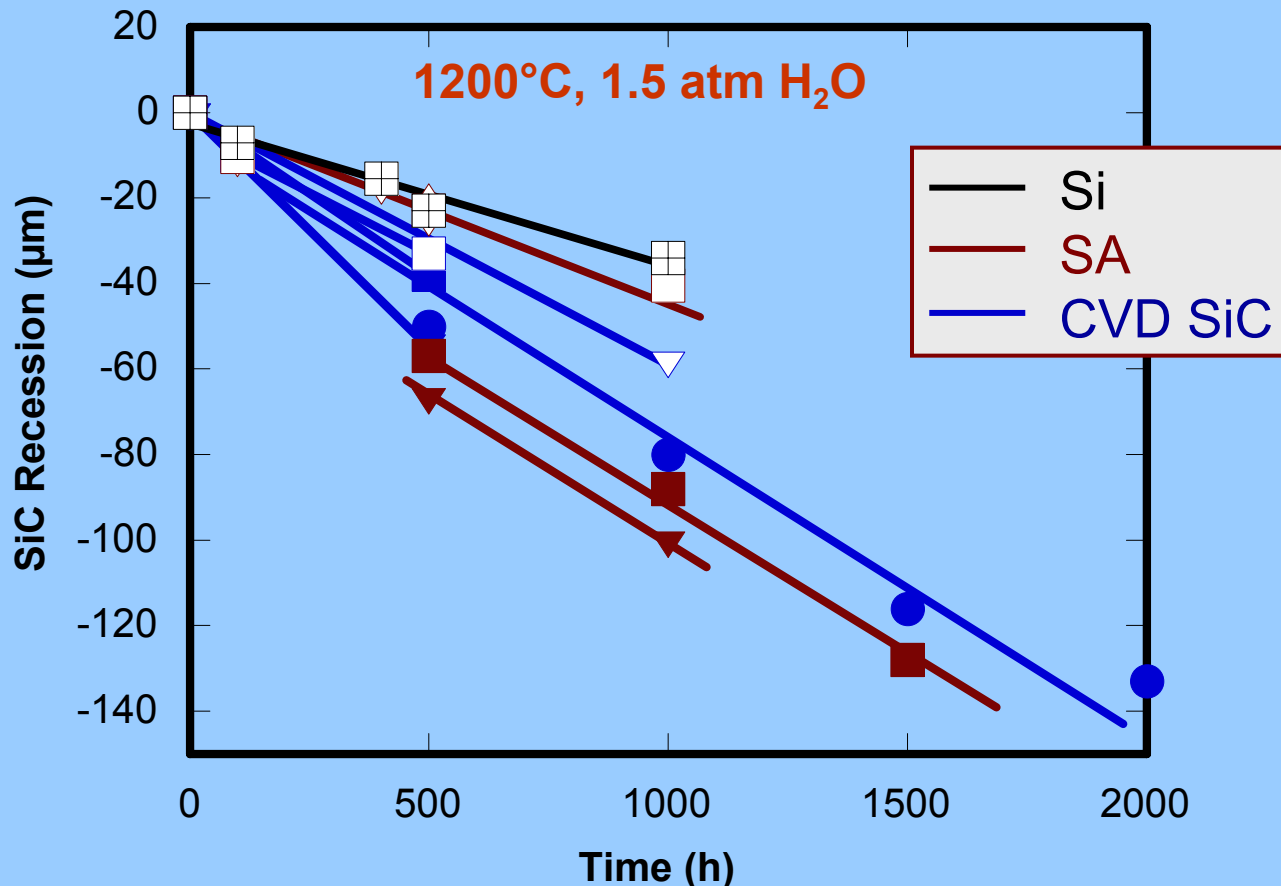
Recession Rate For Silicon Was High, But Lower Than That Of SiC (Both Are CFCC Constituents)

Si: 0.02 - 0.03 μm/h
SiC: 0.04 - 0.10 μm/h

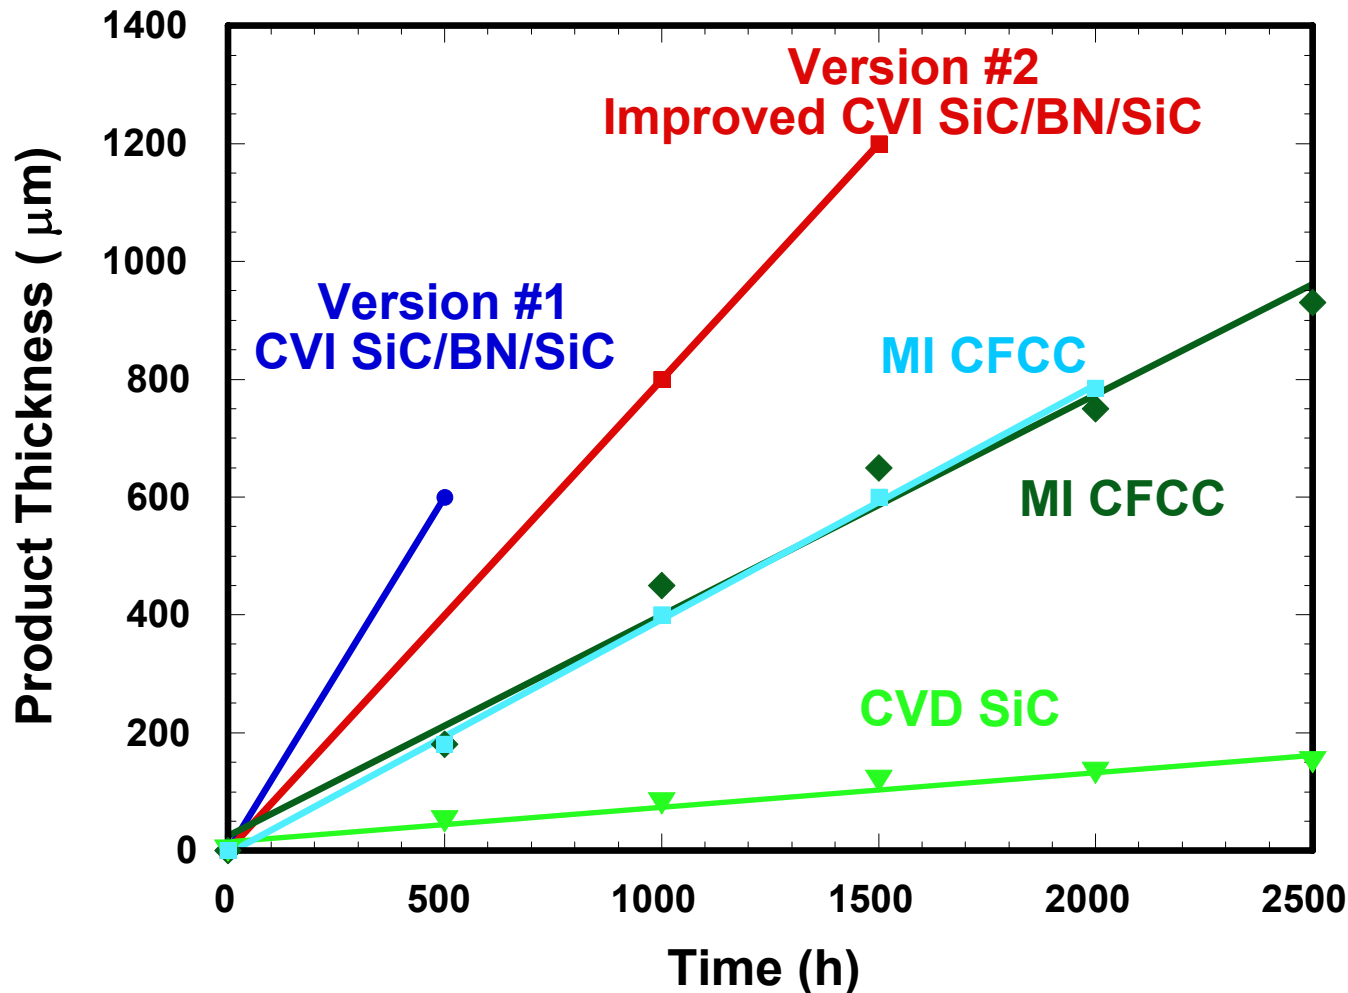
High Rates Of CFCC Oxidative Degradation/Recession Were Measured After Exposure In Keiser Rig

1200°C, 1.5 atm H₂O

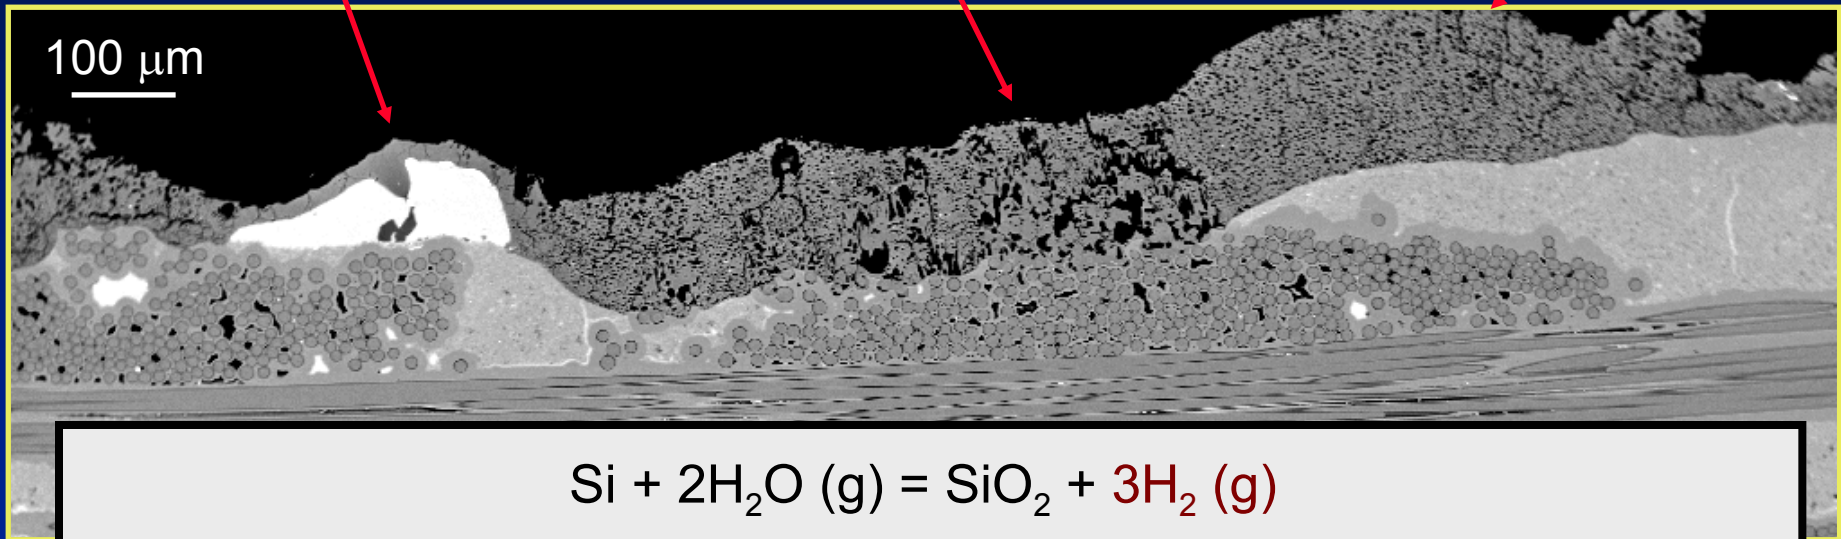
Effects Of Various Constituents On Oxidation Rate And Mode Of Degradation

Modest Oxidation
Silicon

Rapid Attack
fiber + CVI SiC + BN

Faster Reaction
Si + SiC + impurities

MI SiC/BN/SiC, 1200°C, 500 h, 1.5 atm H₂O

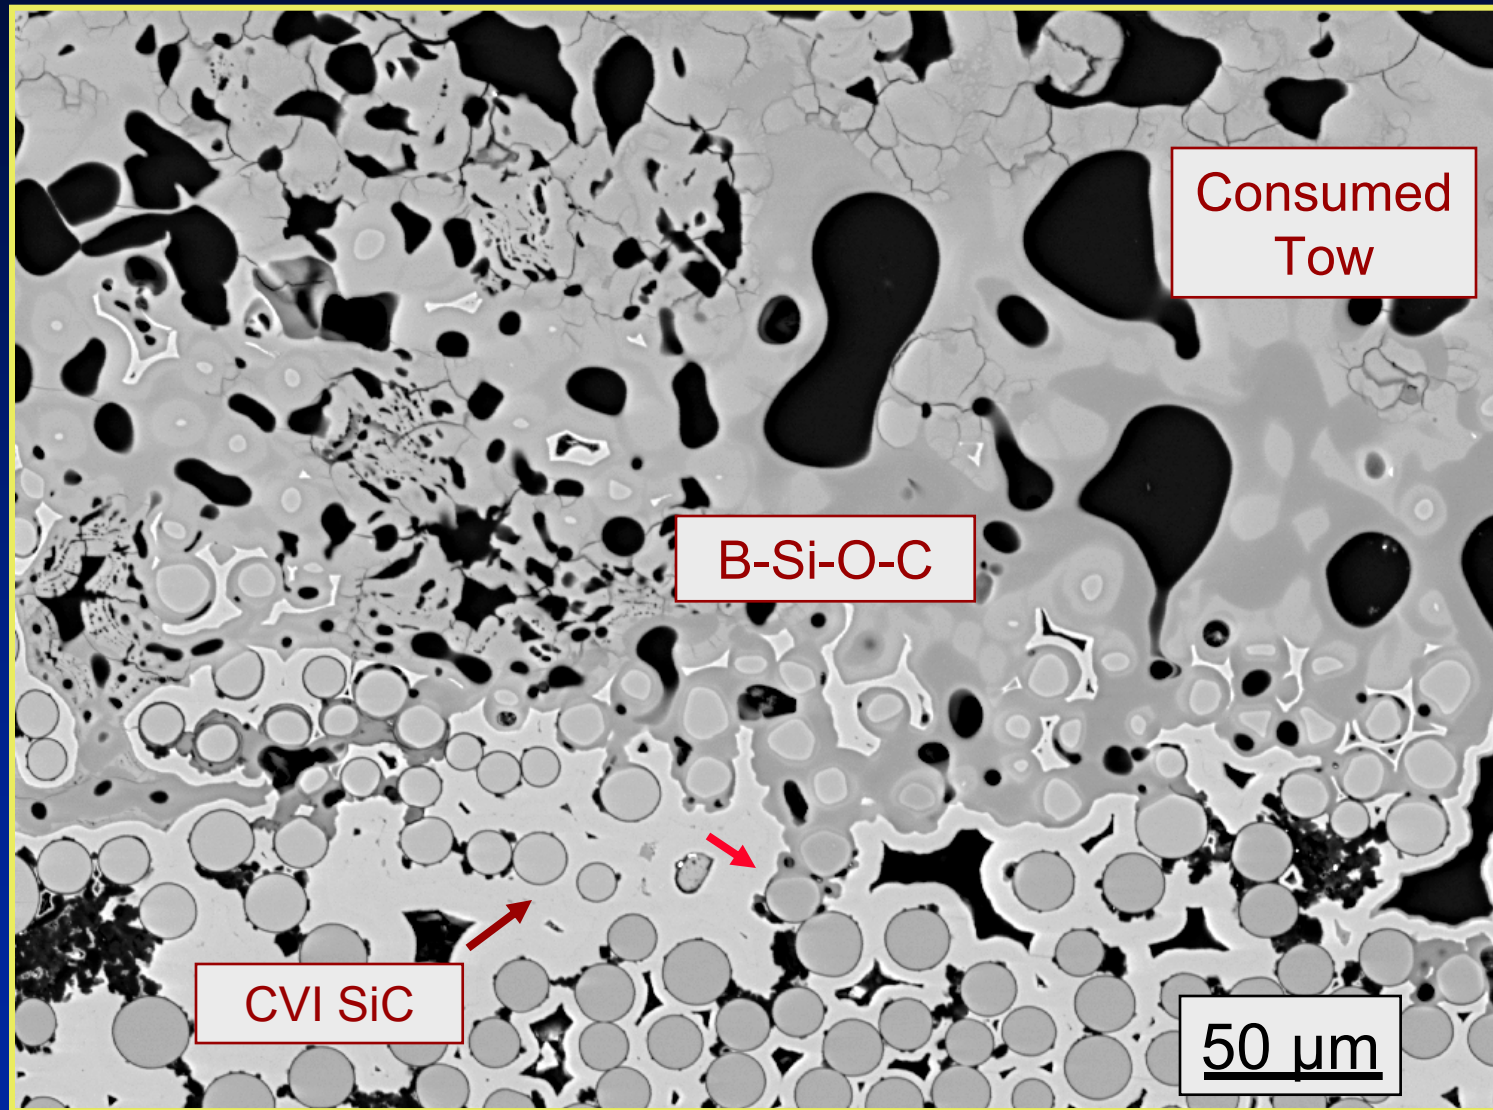
CVI Composite Showed Greater Degradation, But Same Type Of Reactions As MI Composite

1200°C, 1500 h, 1.5 atm H₂O

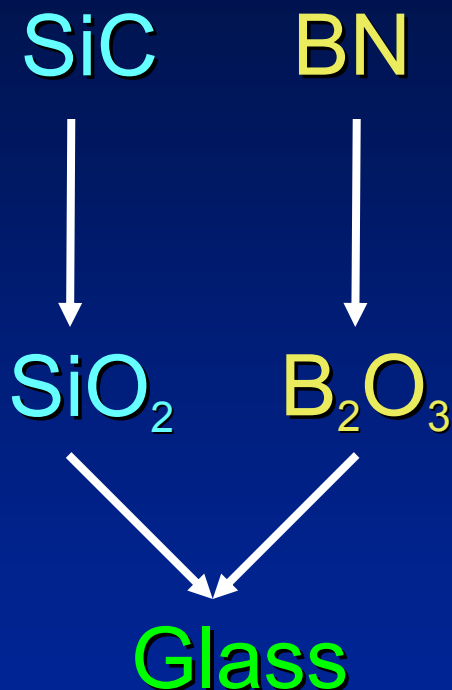
Composite Degradation Not As Sensitive To Gas Velocity Compared To Monolithic Behavior

~1200°C, 1.5 atm H₂O

<u>μm/h</u>
SiC/BN/SiC (~ 30 m/s):	0.5
SiC/BN/SiC (~0.05 m/s):	0.4

*Consistent With Multiple
Oxidation Reactions And
Borosilicate Glass Formation*

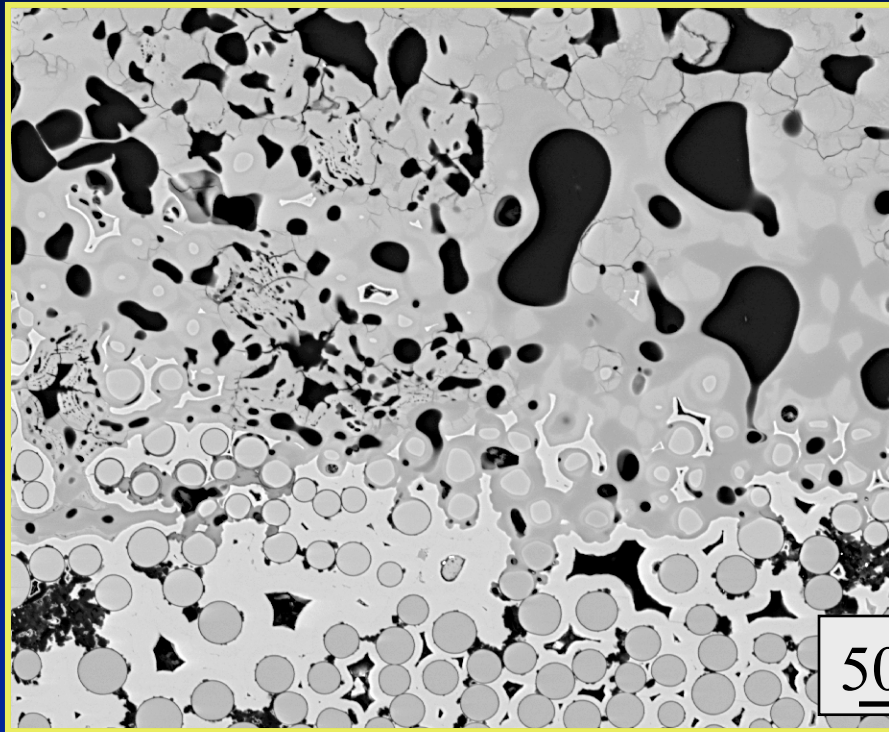
Lab Exposure

Composite Damage Observed In Lab Exposures Was Very Much Like That Of Actual Combustor Liners

CVI SiC/BN/SiC, 1200°C, 1.5 atm H₂O

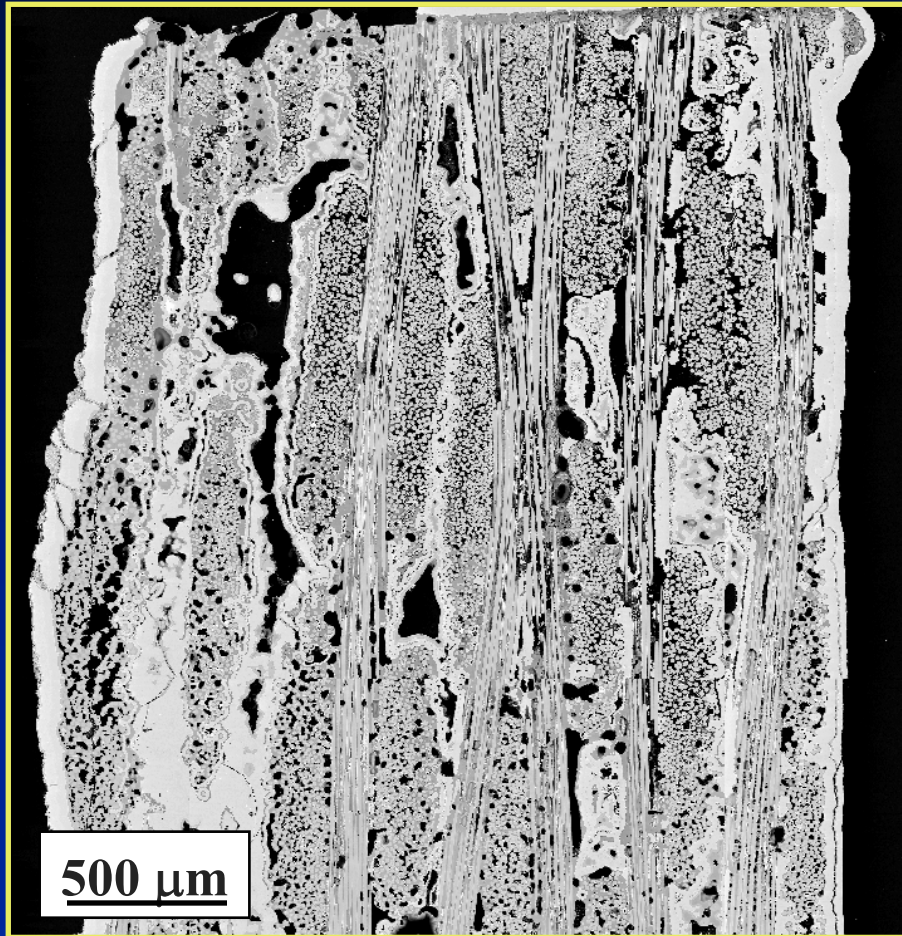
Near top of outer liner

Without An EBC, Significant CFCC Recession And Damage Observed On Surface After Engine Testing

EBCs Are Necessary To Increase The Life Of CFCC Combustor Liners

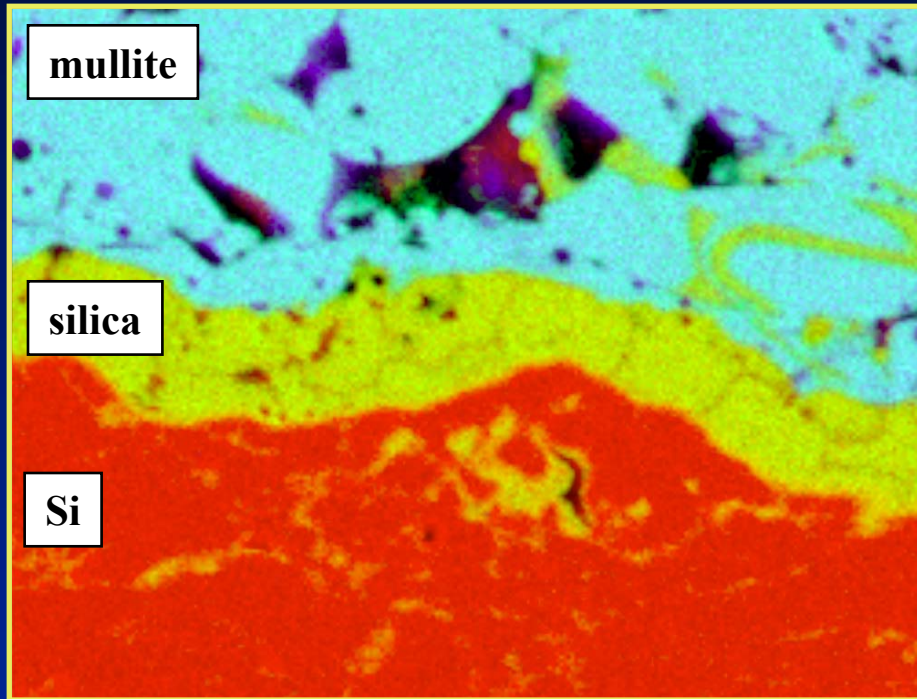
“Dual layer” Mullite/BSAS

Differences Were Observed In Silica Layer Formed Within “Dual” And “Mixed” Layer EBCs

Comparison after 1500 h exposure @ 1200°C in Keiser Rig

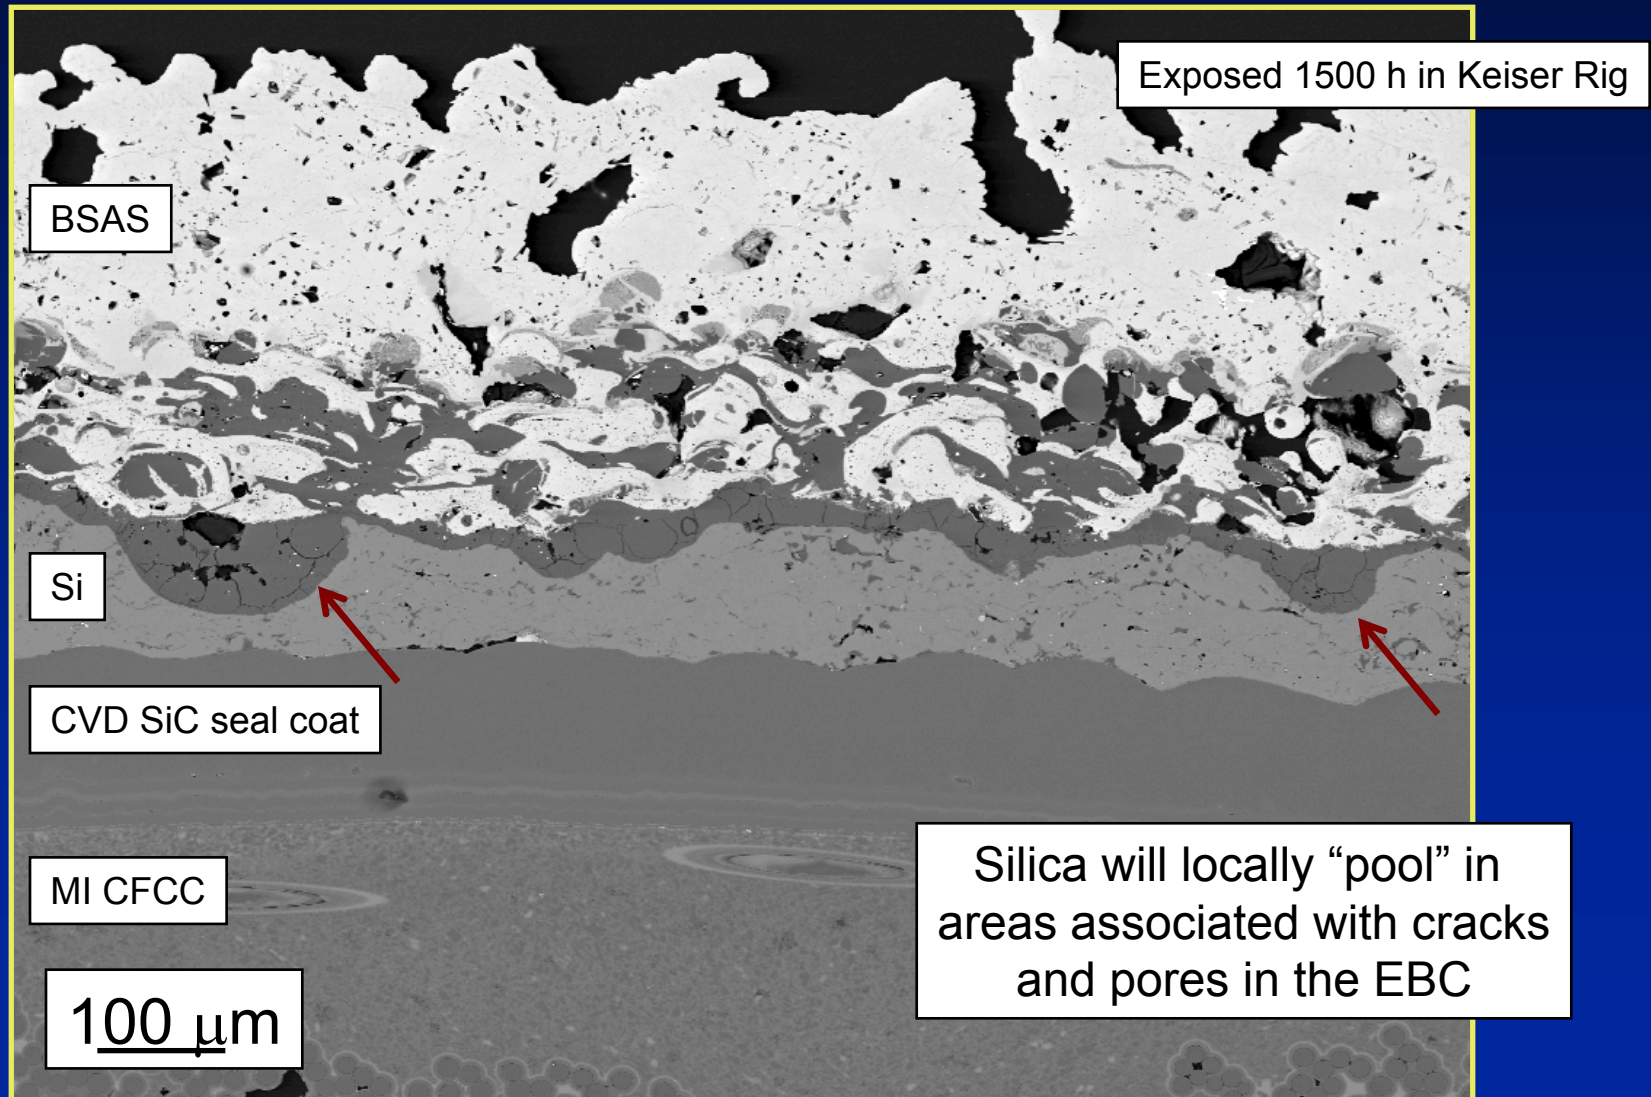
Processing Defects Play A Critical Role In The Effectiveness Of EBCs

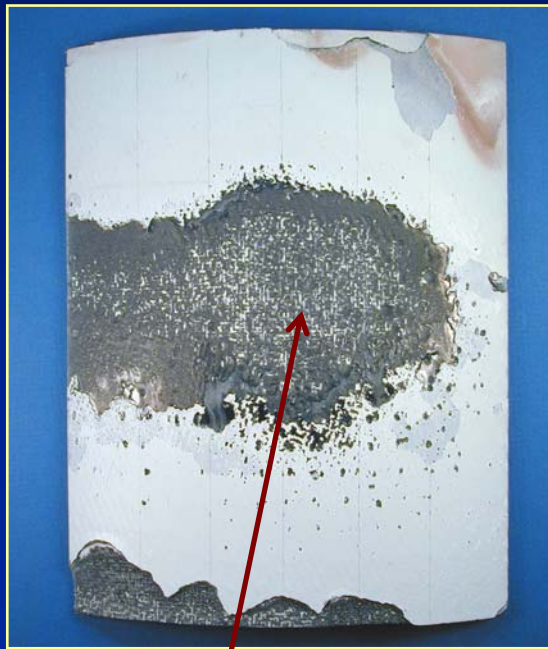
*Recession/volatilization
of BSAS exposing CFCC*

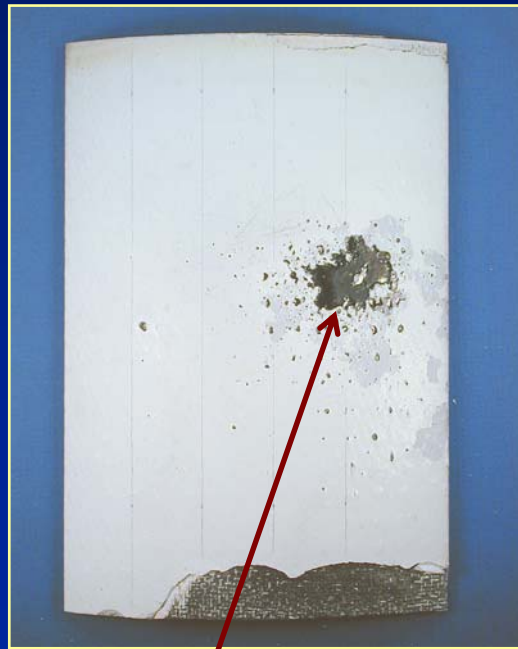
*Recession/volatilization
of BSAS exposing SiC seal coat
and other EBC layers*

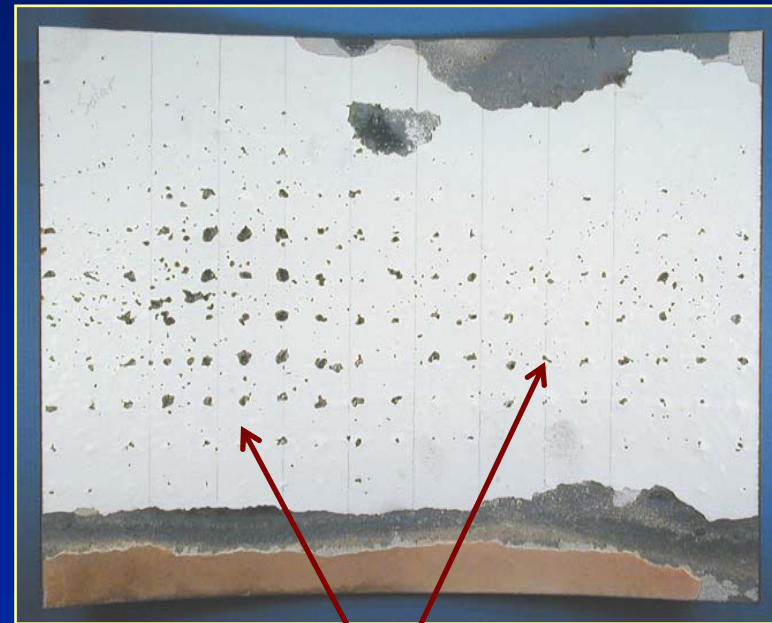
*Pinholes associated with
CVI tooling pattern*

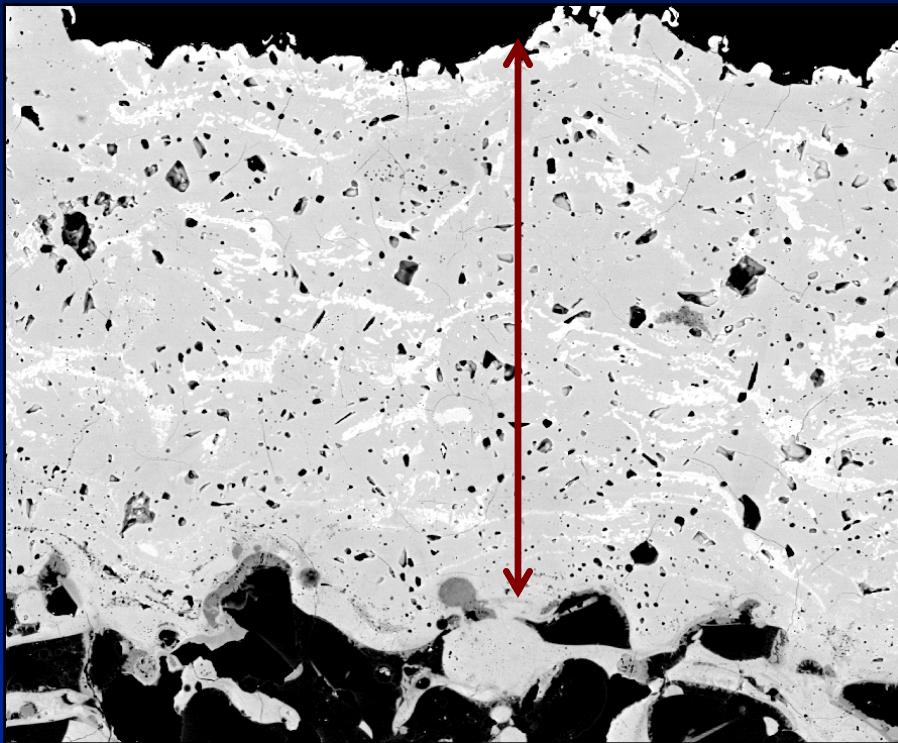
Aft

BSAS Recession Was Observed Regardless Of Type Of EBC (Dual vs. Mixed)

Definite (but unexpected?) volatility issue associated with the BSAS

Outer liner section with mixed-layer EBC

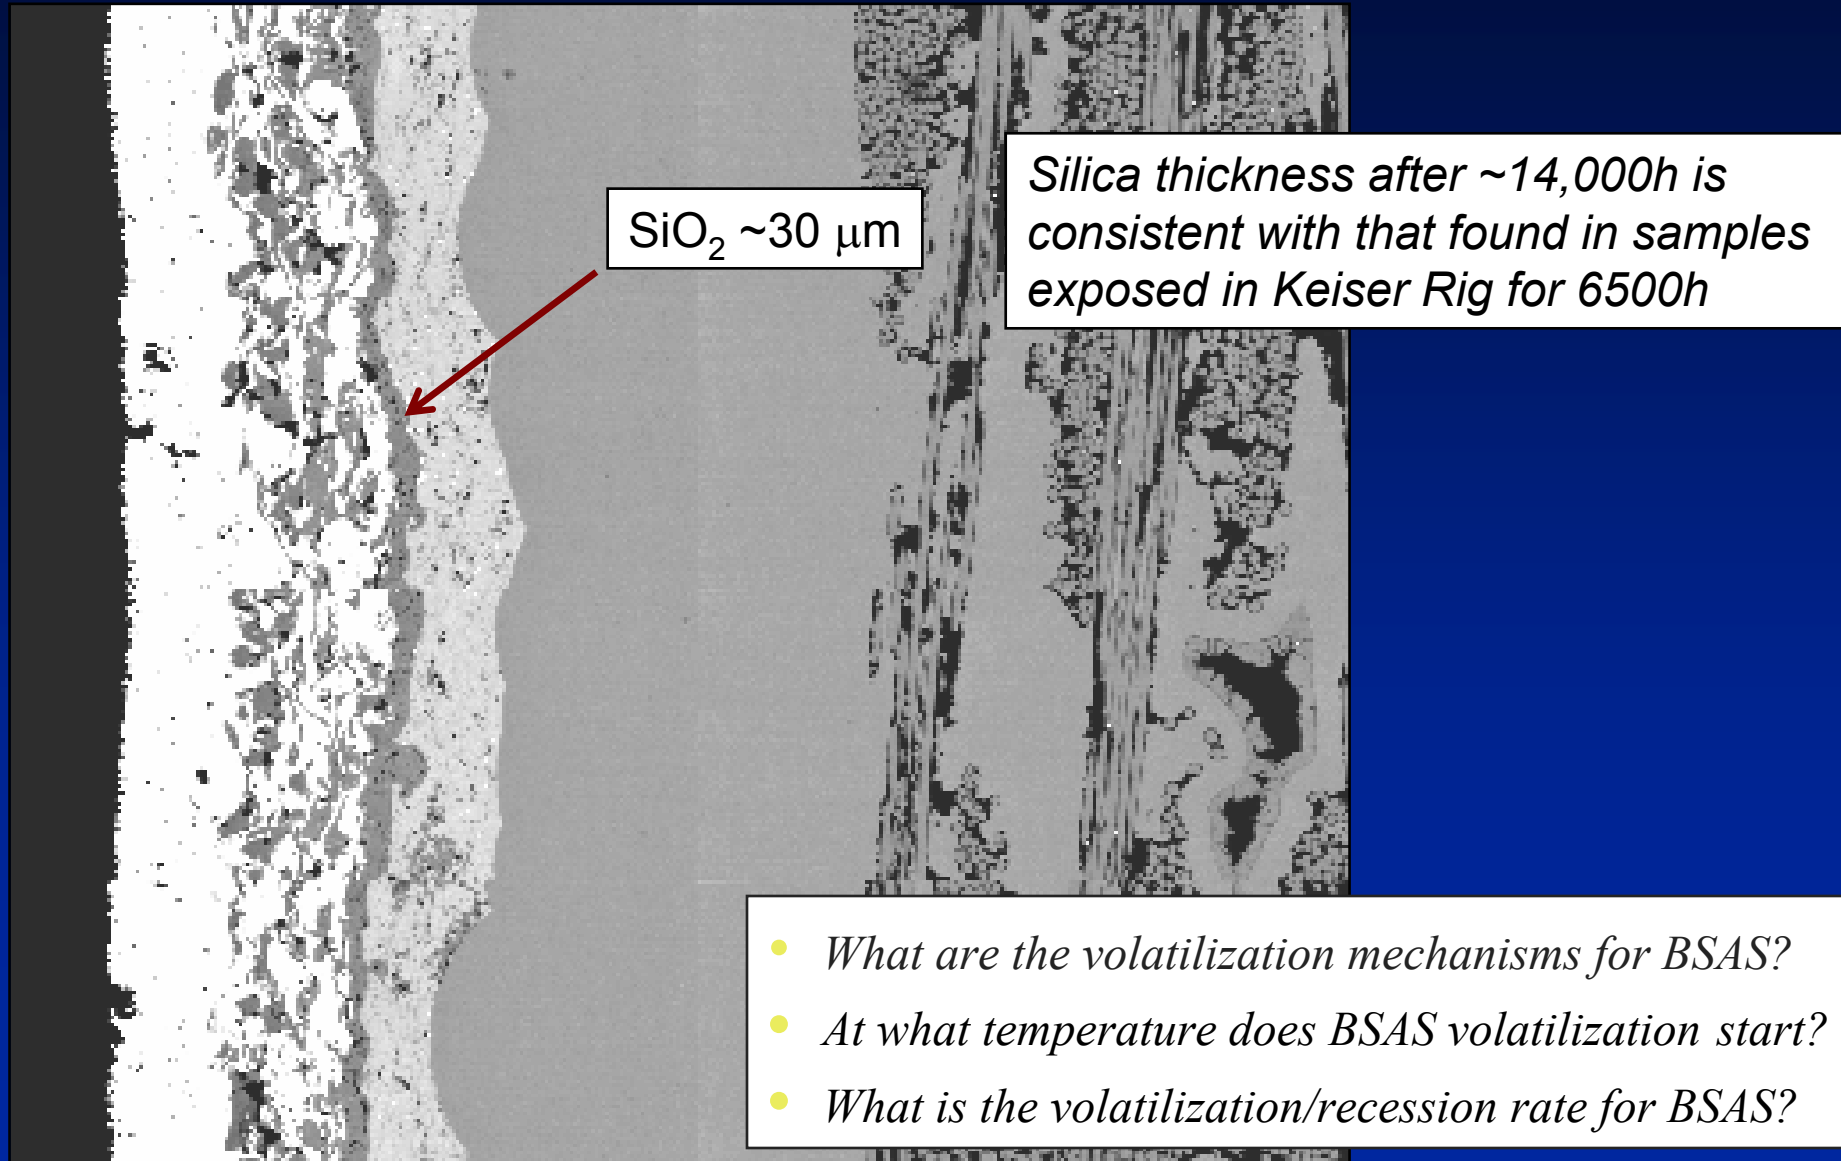
The Mixed-Layer EBC Is Still Protective In Well-Processed Areas Even After Some BSAS Recession

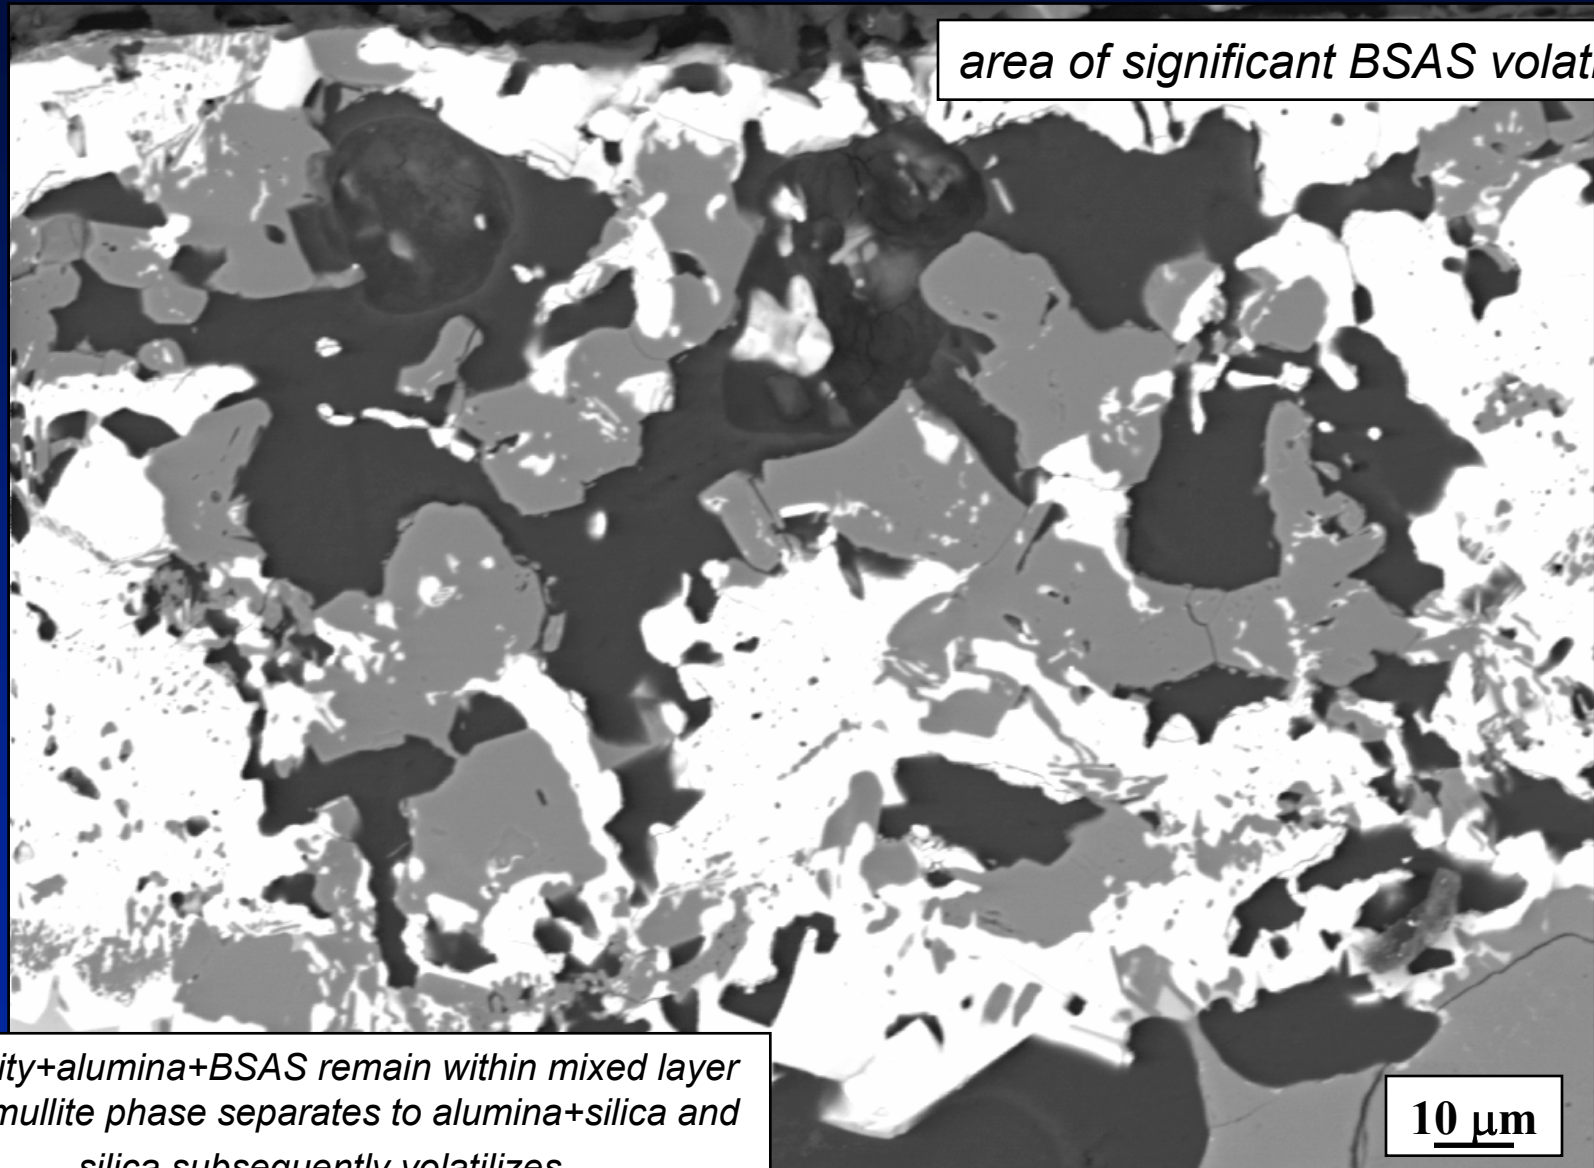
In Areas Where BSAS Top Coat Has Fully Recessed, Exposed Mullite Degrades Rapidly

area of significant BSAS volatilization

*porosity+alumina+BSAS remain within mixed layer
after mullite phase separates to alumina+silica and
silica subsequently volatilizes*

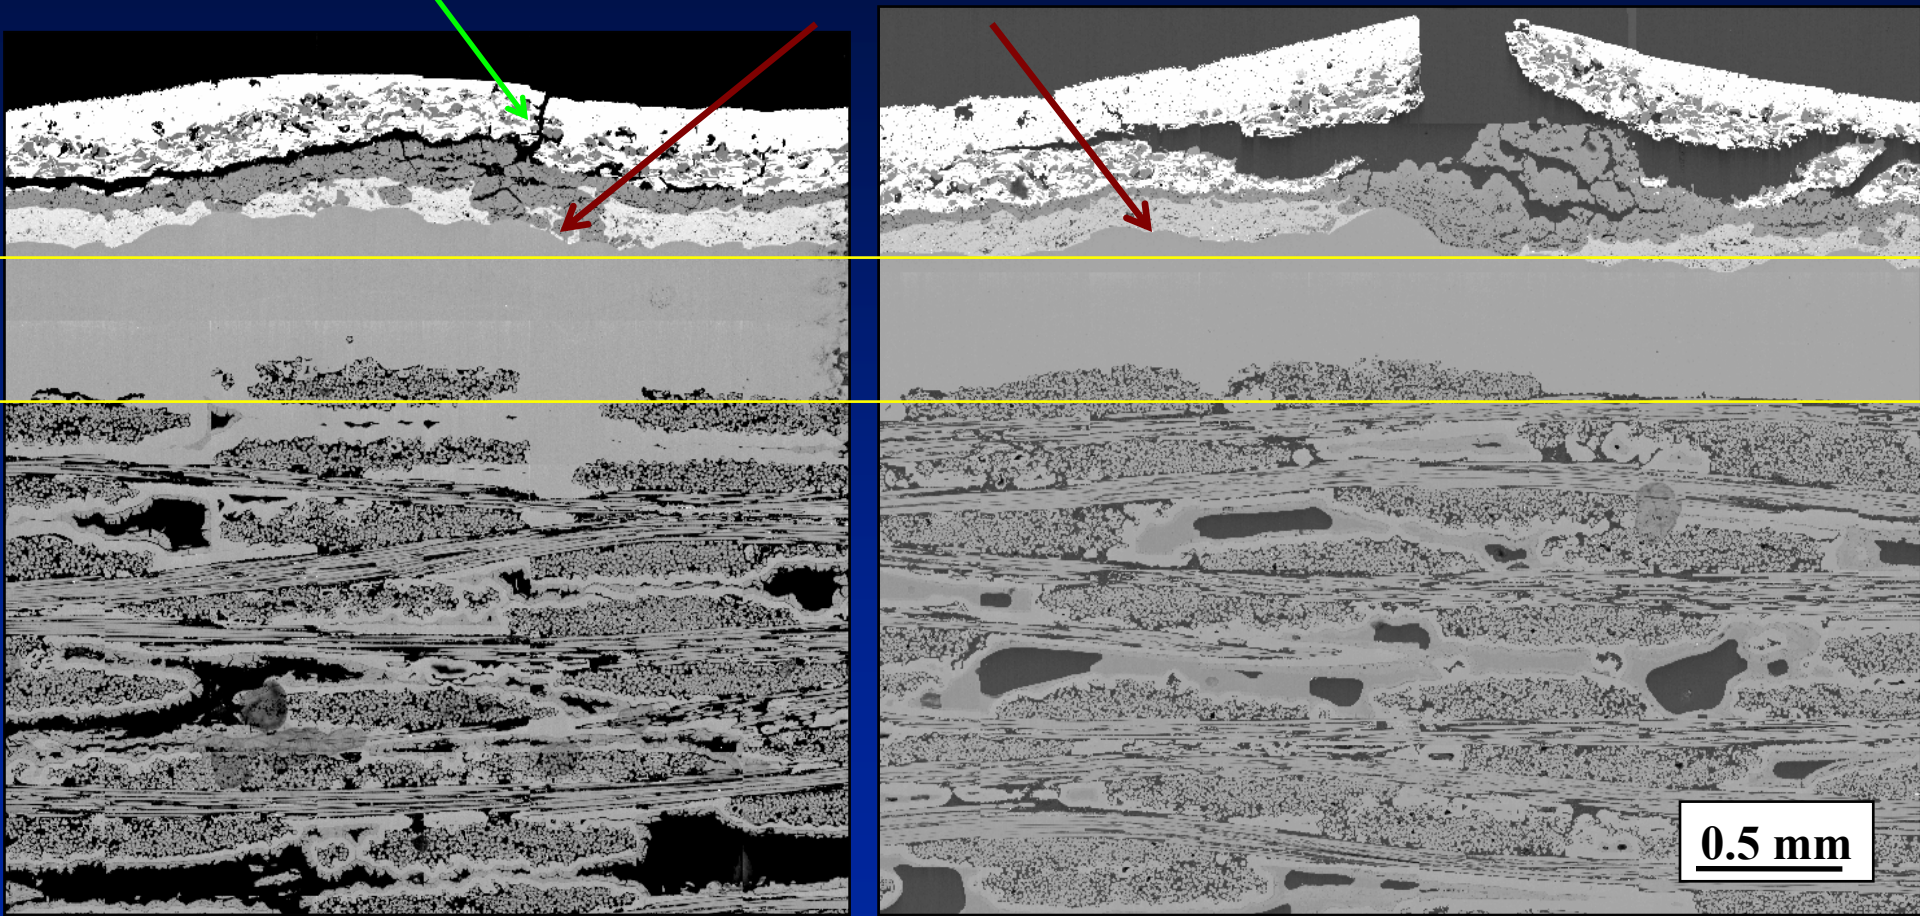
Tool Bump Areas Showing Early Stages Of EBC Spallation In Cooler Sections Of Outer Liner

crack

Tooling bumps

The as-processed EBCs generally have a through-thickness crack associated with the tool bumps (or any other surface asperity)

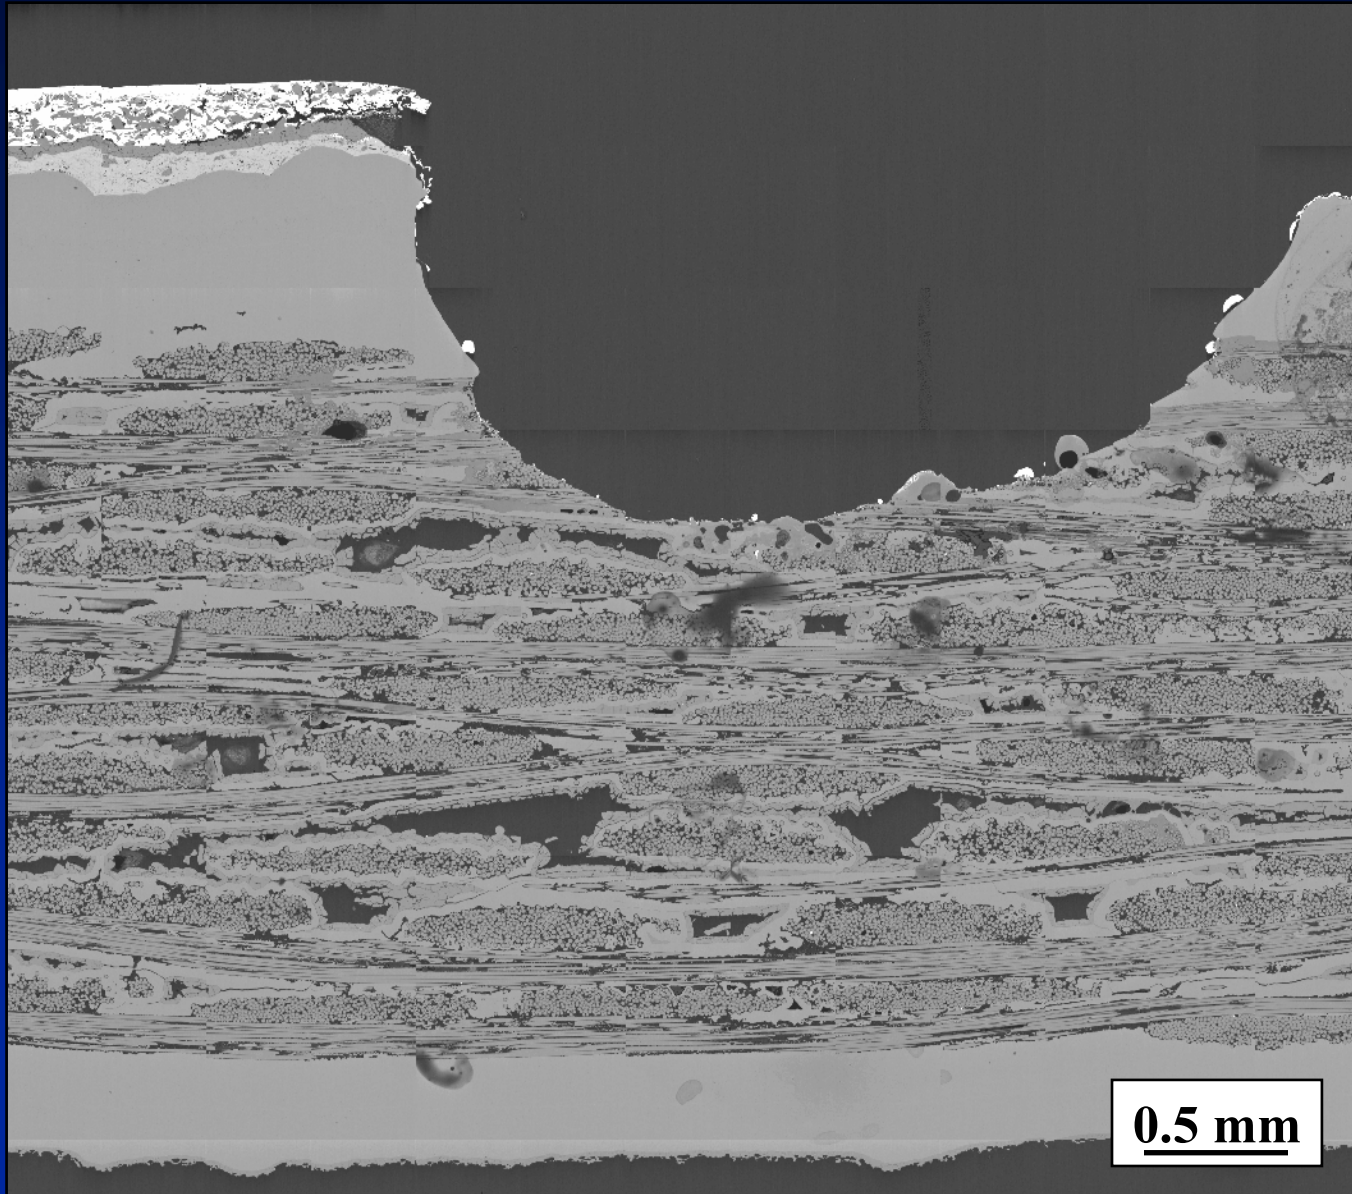
Typical Cross-Section Through Pinhole On Surface Of Outer Liner Shows Accelerated Oxidation Of CFCC
